Erosional Hazards on the Point Grey Cliffs:

Strategies for Classifying Risk & Priority Areas Using ArcGIS

GEOB 308 - Quaternary and Applied Geomorphology

Capstone Assignment: Geomorphic Process in the Fraser Lowlands

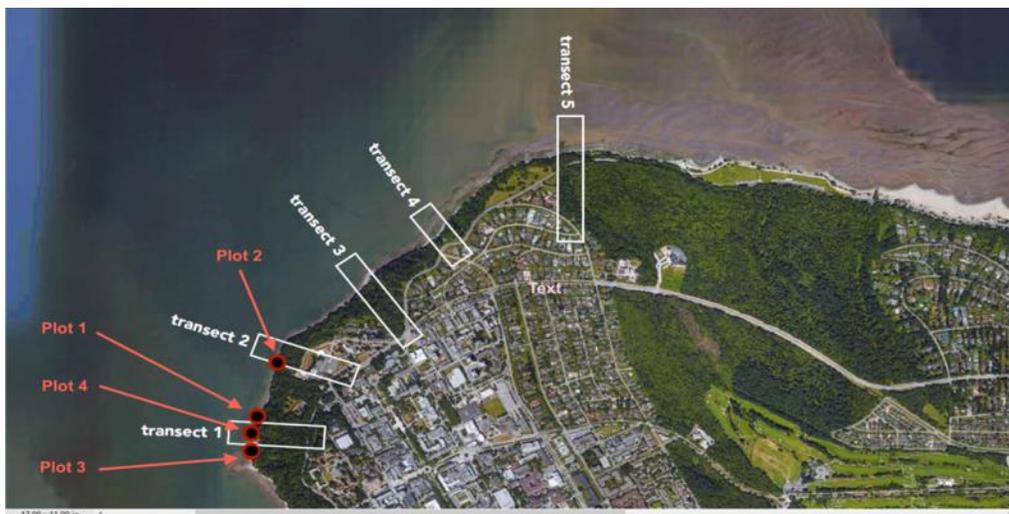
Fig. 3: Plot locations lined up in relation to the Living Breakwaters Vegetation transects. Data from transect 2 was used to evaluate vegetation for plot 2. Data from transect 1 was used to evaluate vegetation for plots 1, 3, and 4.

(Vegetation): The presence of living vegetation, in particular large trees with deep roots, increase slope stability (Watson, et al., 1999). We focused mostly on quantifying the impact of canopy species (trees), rather than understorey species. This decision was made because we were unable to find sufficient literature distinguishing the cohesion abilities of various understorey species that we surveyed. We combined our recorded site data with previously-recorded vegetation data on the Point Grey Cliffs from the UBC Living Breakwaters Project. We examined the role of vegetation quantitatively through empirical data from both our own site visits, as well as data from the Living Breakwaters Study to calculate the cohesive abilities of the trees. Qualitatively, we assigned ‘points’ based off of observed stability criteria (Table 1,3). Relevant data included tree locations, tree species, diameter at breast height (DBH), depth of Q1, the presence of cliff face vegetation, and the presence of slumped trees (Table 2), (Fig. 3).
